Sandyford Road SHD Arboricultural Report
Trees at Proposed Site at
'Karuna' and 'Glenina'
Sandyford Road
Sandyford
Dublin 18
April 2022

The Tree File Ltd
Consulting Arborists
Ashgrove House
26 Foxrock Court
Dublin 18
D18 R2K1
086-3819011

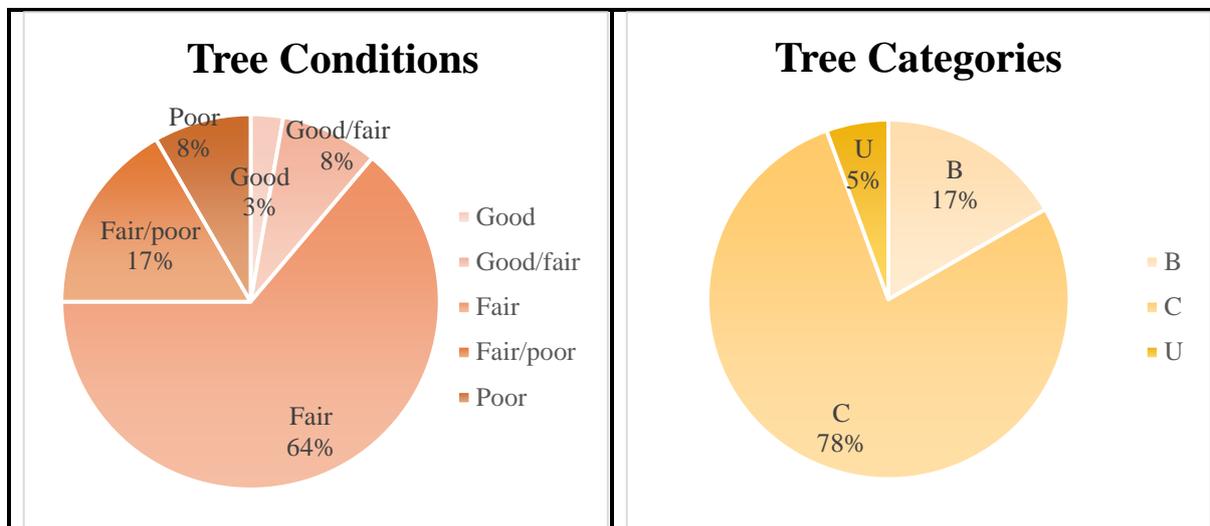
Fig 1

- 4.4 Each of the three tree lines has been previously decapitated, and their crowns support substantial crown regeneration since that cutting. Some trees show signs of mechanical damage and failure considered typical for the species in later life and raise concerns regarding sustainability. Such concerns are exacerbated in light of generally known issues relating to Lawson and Leyland Cypress Alignments regarding an inability to apply tangible management over time and their ability to outgrow their scenarios. Therefore, each line of trees encountered is mature, large but beyond any reasonable potential for reducing that size. Considering the apparent onset of mechanical failure, then that potential lifespan is considered minimal, and further deterioration must be expected over forthcoming years.

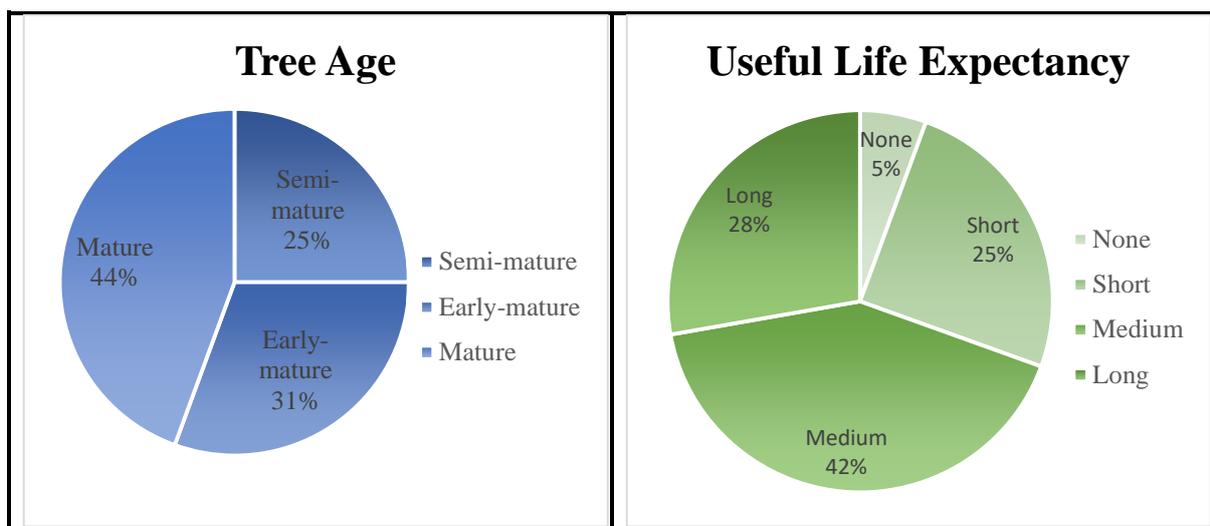
Fig 3

4.6 Within the garden area, we find two particularly significant Eucalyptus. These trees are in broadly good condition; however, both have been interfered with in the past and apparently decapitated. Crown renewal is extensive, and both trees remain vigorous with substantial potential for continued growth over time.

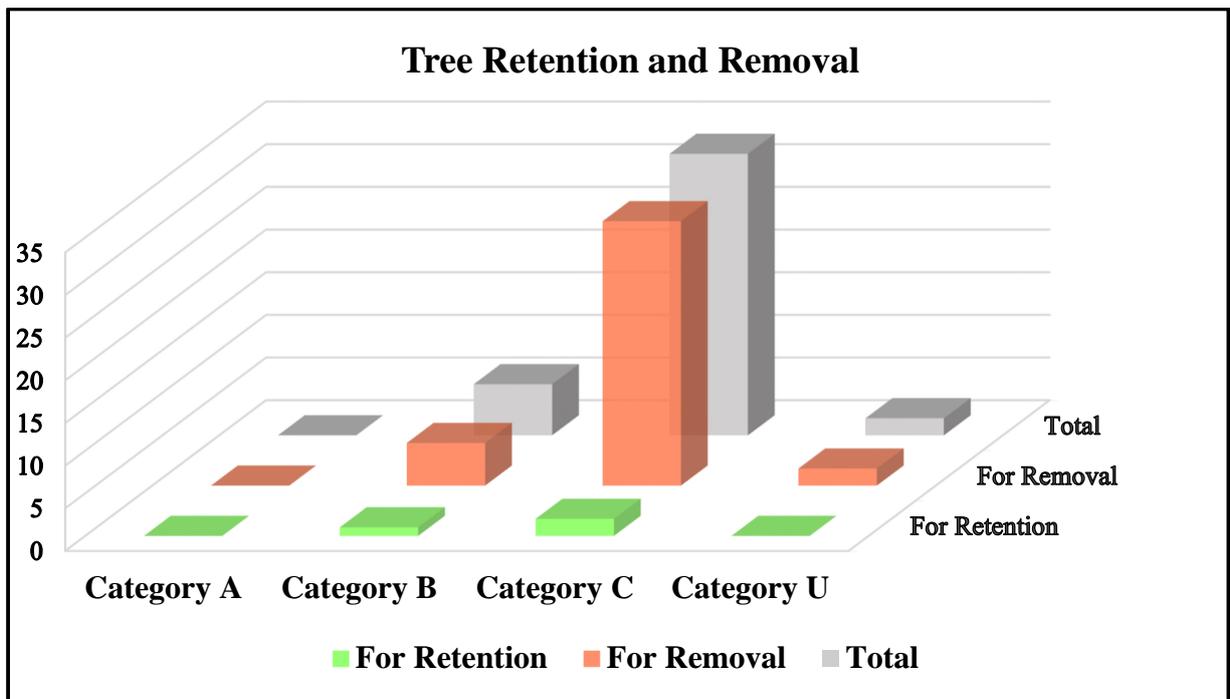
Fig 5 Graphic Representation of Tree Loss/Retention Scenario
